# Spanish Bank Creek Restoration Project

## Project Summary 1994–2007

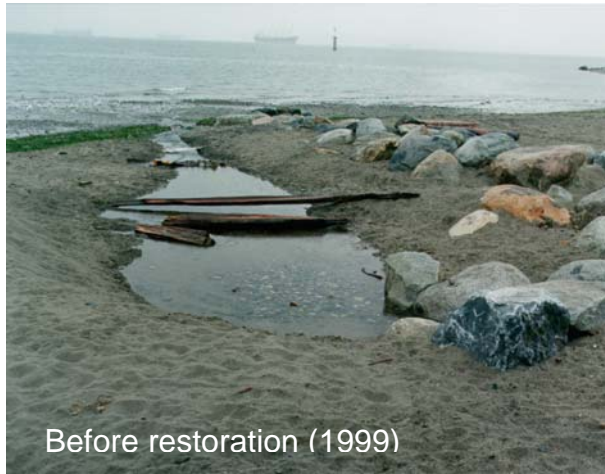
Before restoration (1999)

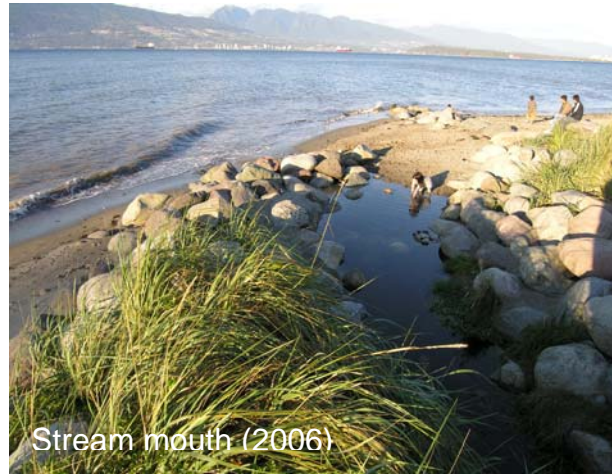
Stream mouth (2006)

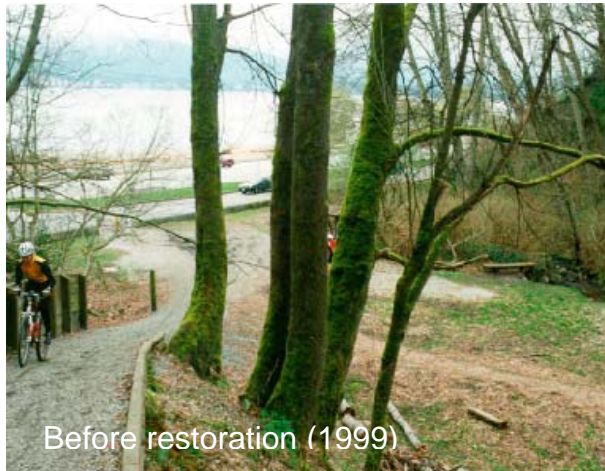
Before restoration (1999)

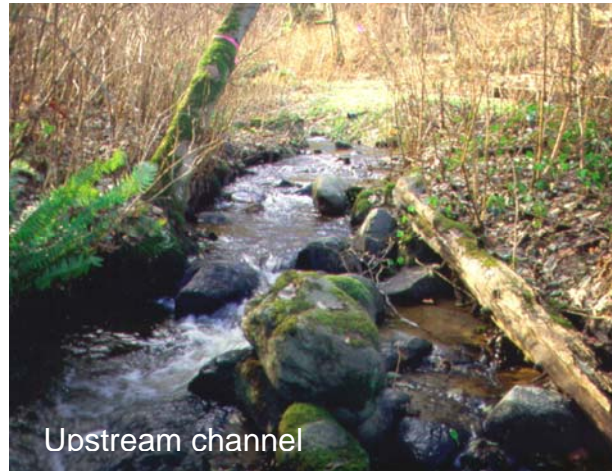
Upstream channel

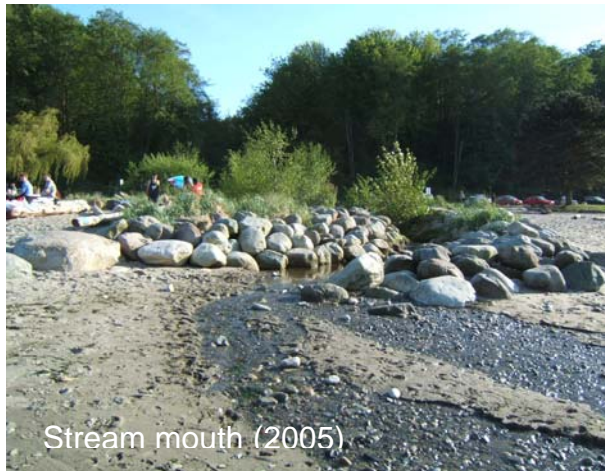
Stream mouth (2005)

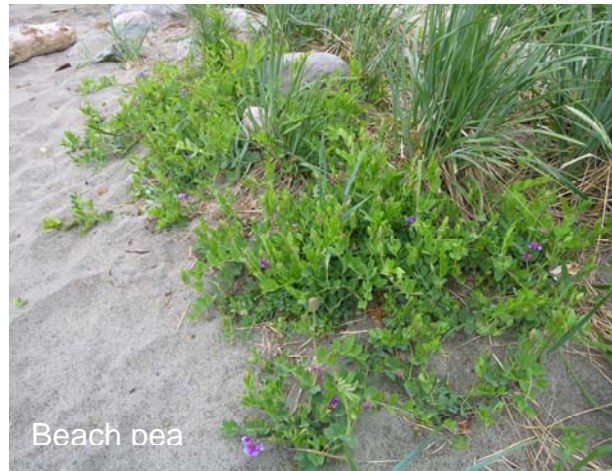
Beach dune
